LESSONS LEARNED FROM WALL FAILURE

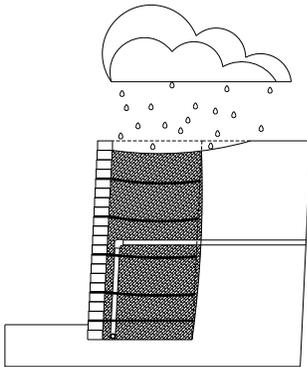
- Heavy rain from the adjacent property saturated the fill area behind the wall. Settlement, averaging 8 in. (20.3 cm), extending approximately 9 ft (2.8 m) behind the wall was experienced because of the lack of water management and the resulting saturation of the soil. Surface water runoff from several lots simply followed a pre-existing grade and stopped at the back of the wall. A drainage outlet was not incorporated into the design.

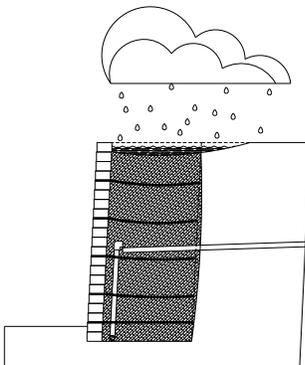
- During the construction care was taken to route down spouts from the house gutters through two, 4 in. (10.2 cm) rigid plastic pipes. Subsequent to the settlement the rigid plastic drain pipes broke directly behind the wall. It can be assumed that during the settlement the geogrid directly behind the wall experienced unanticipated loading, and possible damage, caused by the soil consolidation.

- During frequent rain falls that followed, the settlement area turned into a ponding area, holding water runoff. This inability for the site to effectively drain water away from the soil resulted in constant saturation of the soil.
- Continuing rain fall resulted in an internal stability failure. A localized slip plane materialized, caused by a build up of hydrostatic pressure and by a reduction in strength of the soil. These conditions undoubtedly created a bulge in the wall at approximately 4 ft (1.2 m) above grade.

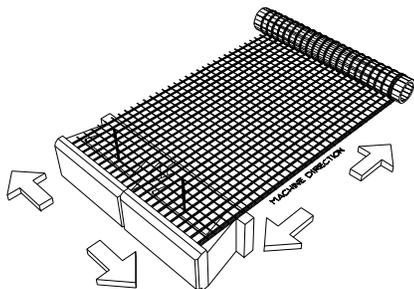
- An internal failure plane, following a log spiral configuration, resulted in a section of wall approximately 8 ft (2.4 m) high by 50 ft (15.2 m) long collapsed onto the street below.

- In addition to the conditions described it was determined that two of the layers of geogrid had been installed with the machine direction parallel to the face of the wall.
